WOOD DESTROYING PESTS AND ORGANISMS INSPECTION REPORT

Building No. 1377 Street, City, Zip Camino Robles Way, San Jose, CA, 95120	Date of Inspection 10/01/07	No. of Pages 7
THRASHER TERMITE & PEST CONTROL, INC. 17427 Farley Road West Los Gatos, CA 95030-3308 Ph: (408) 354-9944 Fax: (408) 395-7934		
Firm Registration No. PR 5009	Report No. 33799	Escrow No. 0613007589
Ordered By: Coldwell Banker - Holly Barr 1712 Meridian Avenue San Jose CA 95125	Property Owner/Party of Interest: John & Kathleen Fischler 1377 Camino Robles Way San Jose CA 95120 Fischler & Fischler 1377 Camino Robles Way San Jose CA 95120	Report Sent To: Old Republic Title 1900 The Alameda San Jose CA 95126 Monica DiMaggio
COMPLETE REPORT <input checked="" type="checkbox"/> LIMITED REPORT <input type="checkbox"/> SUPPLEMENTAL REPORT <input type="checkbox"/> REINSPECTION REPORT <input type="checkbox"/>		
General Description: Two story, wood framed, single family residence with wood siding exterior.		Inspection Tag Posted: Garage Other Tags Posted: Thrasher... 2/28/06

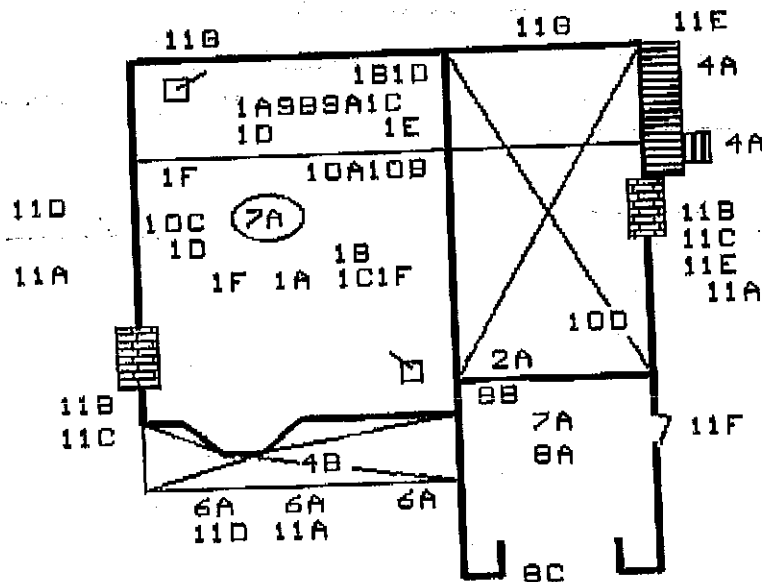
DIAGRAM
NOT TO
SCALE

Item 11E: **FINDING:** Fungus, fungus damage and drywood termite damage were noted to the wood siding at the locations indicated on our diagram.

RECOMMENDATION: Remove the damaged siding as necessary and check for concealed damage. If no further damage is found, new materials will be installed, sealing all voids. The repaired areas will be primer painted only. If any further damage is found, a Supplemental Report will be issued with our additional findings and cost. **NOTE:** An exact match of the siding cannot be guaranteed. If an exact match is not found, we will use siding of similar quality and design. **NOTE:** Upon completion of these repairs, there may be a visible seam or the Z-bar may be evident.
