# WOOD DESTROYING PLANTS AND ORGANISMS INSPECTION REPORT

Building No.	Street, City, Zip	Date of Inspection	No. of Pages
1086	Byerley Avenue, San Jose, CA, 95125	07/10/09	8
<b>THRASHER TERMITE &amp; PEST CONTROL, INC.</b> 17427 Farley Road West Los Gatos, CA 95030-3308 Ph: (408) 354-9944 Fax: (408) 395-7934

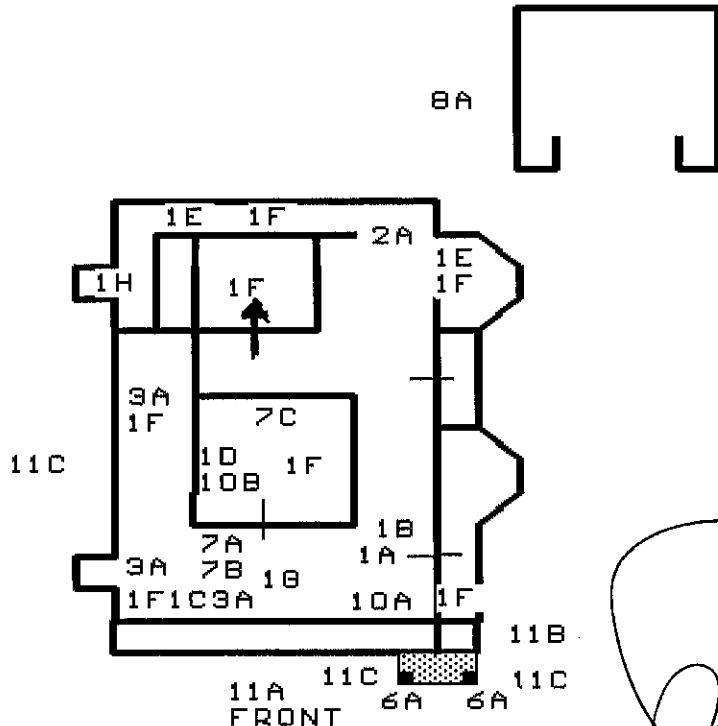
DIAGRAM NOT TO SCALE

An inspection has been made of the structure(s) shown on the diagram in accordance with the Structural Pest Control Act. Detached porches, detached steps, detached decks and any other structures not on the diagram were not inspected.			
Subterranean Termites <input type="checkbox"/> Drywood Termites <input checked="" type="checkbox"/> Fungus/Dryrot <input checked="" type="checkbox"/> Other Findings <input checked="" type="checkbox"/> Further Inspection <input checked="" type="checkbox"/> If any of above boxes are checked, it indicates that there were visible problems in accessible areas. Read the report for details on checked items.

Item 1A: FINDING: Evidence of drywood termite activity was noted at the subarea framing. These infestations appear to extend into inaccessible areas.

Item 1B: FINDING: Drywood termite pellets and/or swarmers were noted at the subarea framing.

Item 1C: FINDING: Evidence of subterranean termite activity was noted at the subarea framing.
