# WOOD DESTROYING PESTS AND ORGANISMS INSPECTION REPORT

| Building No.<br>1955 | Street, City, Zip<br>Ellen Avenue, San Jose, CA, 95125 | Date of Inspection<br>10/22/09 | No. of Pages<br>7 |
| General Description:<br>One story, wood framed, single family residence with stucco and wood siding exterior. | | Inspection Tag Posted:<br>Garage | |

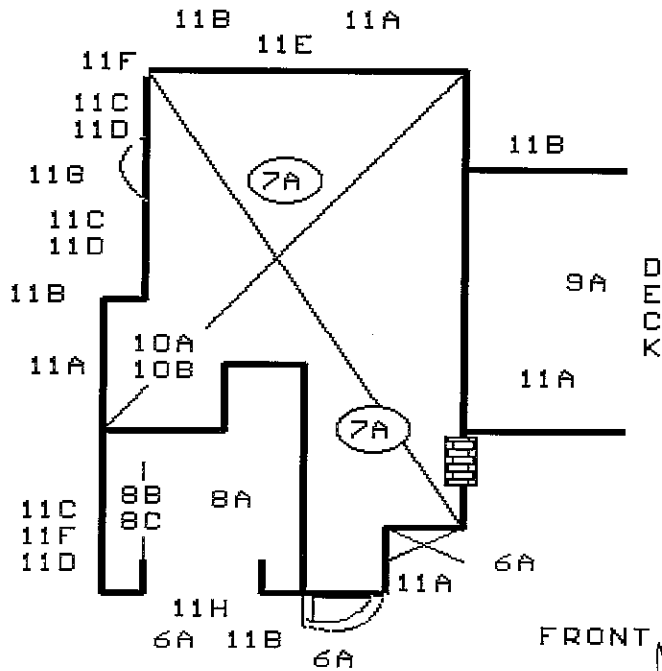
DIAGRAM NOT TO SCALE

| An inspection has been made of the structure(s) shown on the diagram in accordance with the Structural Pest Control Act. Detached porches, detached steps, detached decks and any other structures not on the diagram were not inspected. | | | |

Item 8B: FINDING: Evidence of drywood termite activity was noted at the garage framing. These infestations appear to extend into inaccessible areas.

Item 8C: FINDING: Drywood termite pellets and/or swarmers were noted at the garage framing.
